# Retrofit Reality Check: Lessons from Real-World Projects

*AIA Learning Credits: 1.5 LU/HSW  
RAiNA AIA Provider #: 502111378  
Course #: RAINA-CONF25-5  
November 5, 2025*

# RETROFIT REALITY CHECK: LESSONS FROM REAL-WORK PROJECTS

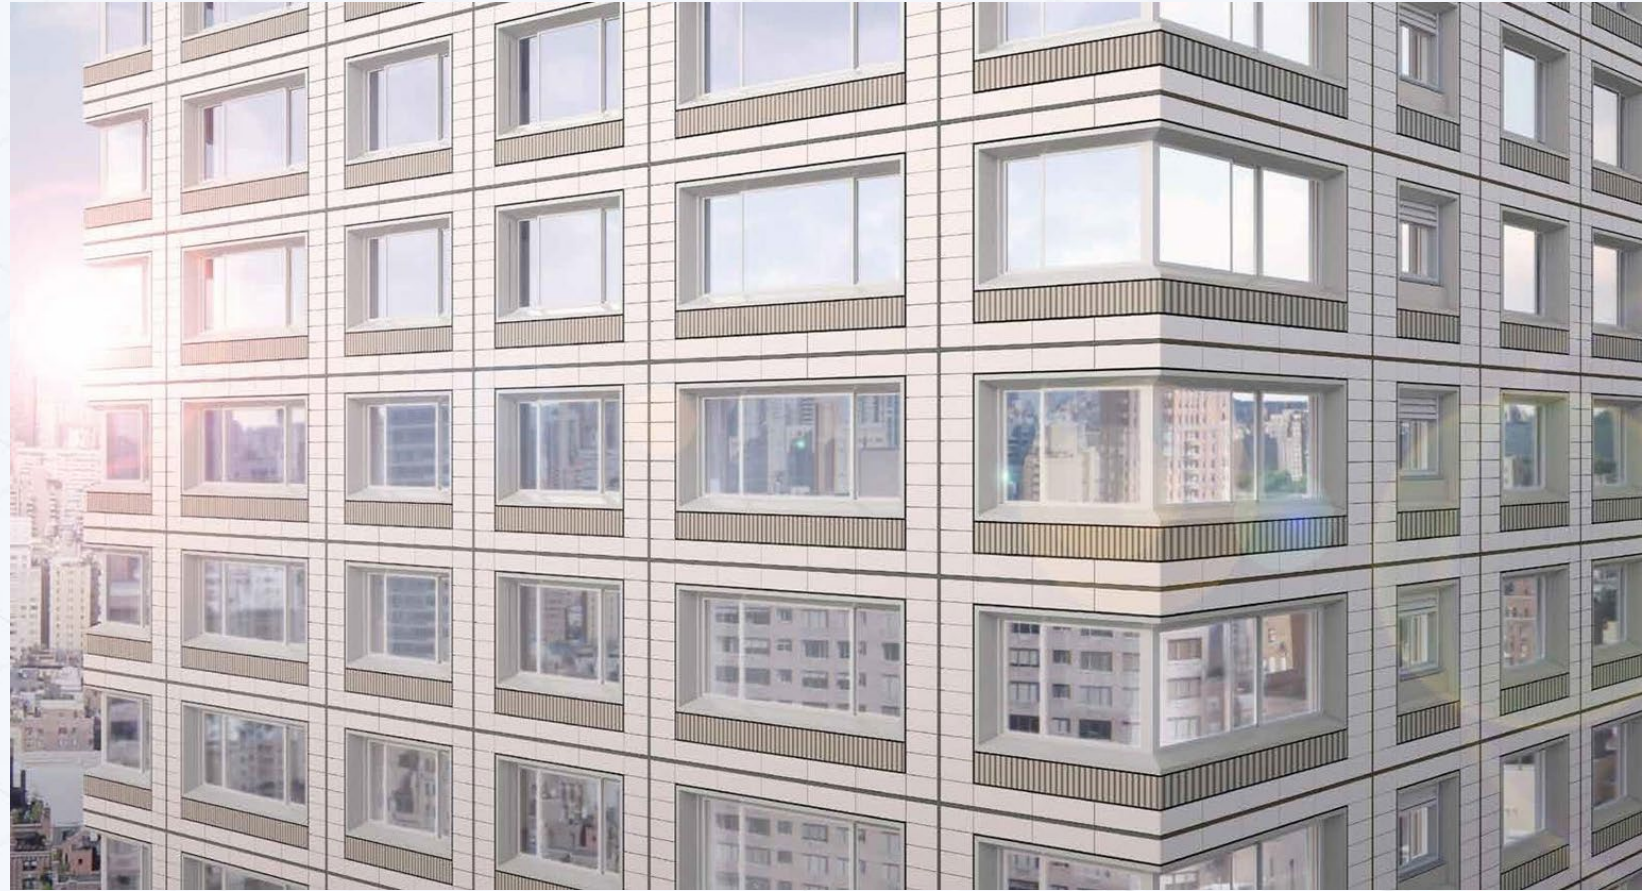
## Scope of work:

- Repair and coat existing masonry wall
- Layout and Install new vertical carrier tracks
- Install new window surrounds and PTAC grilles
- Install exterior Rockwool insulation
- Install terra cotta tile

Design by SOM NY

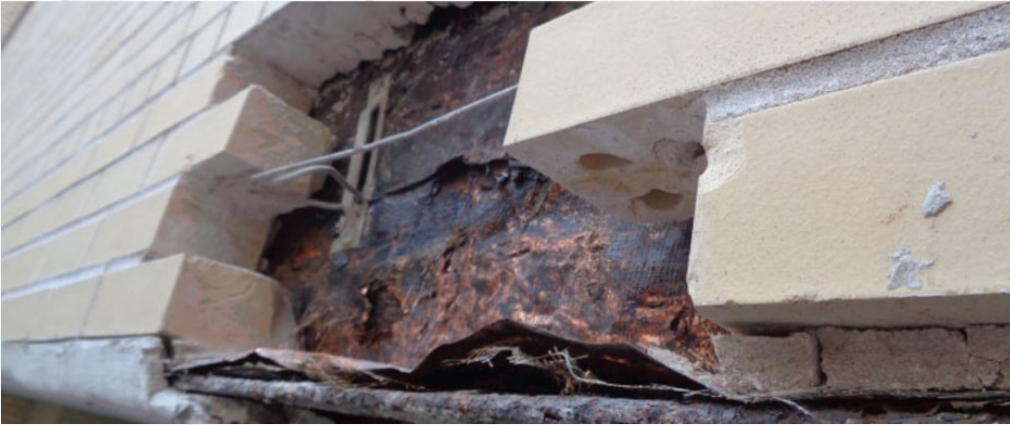
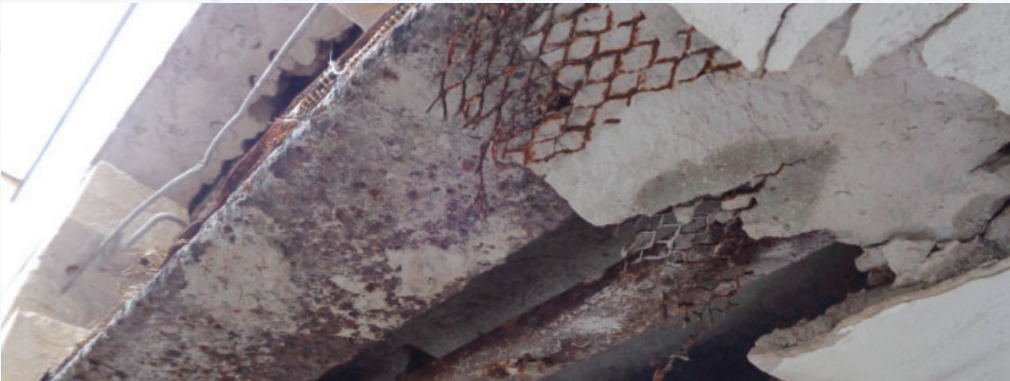
## Relieving Angles and Lintels

- Probes show spalled and corroded relieving angles and lintels
- Inconsistencies with existing structure (brick, cmu, steel)

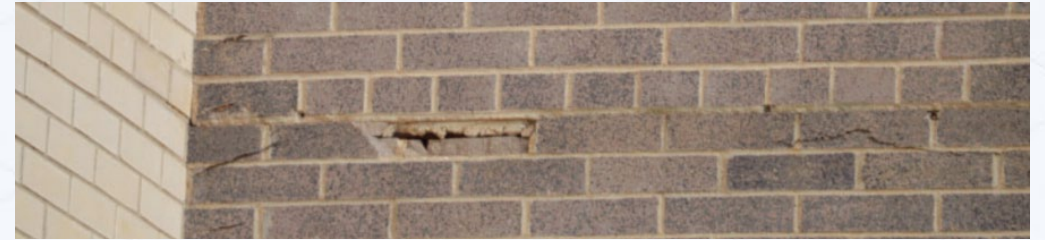
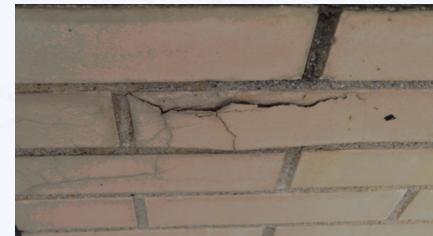
## Existing Brick

- Failing brickwork
- Out of plumb
- Failing caulk joints

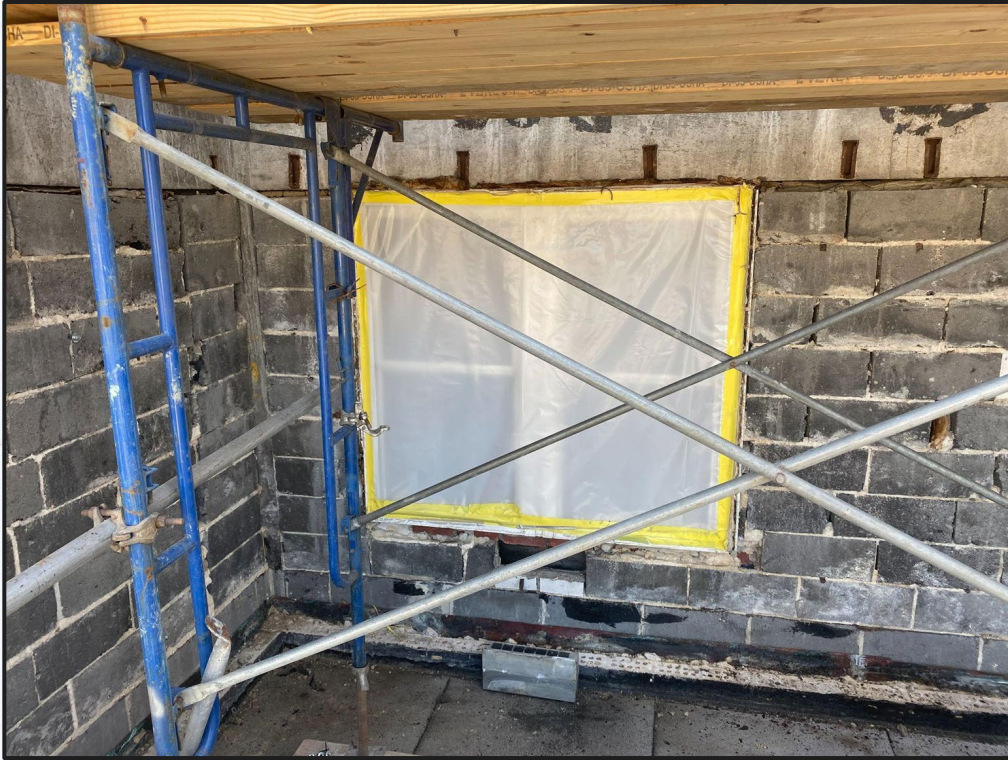
## Demo / Unforeseen Conditions

- Large voids in non-structural CMU back-up wall
- Substantial discrepancies with existing concrete structure
- Projection of existing windows to remain into cavity

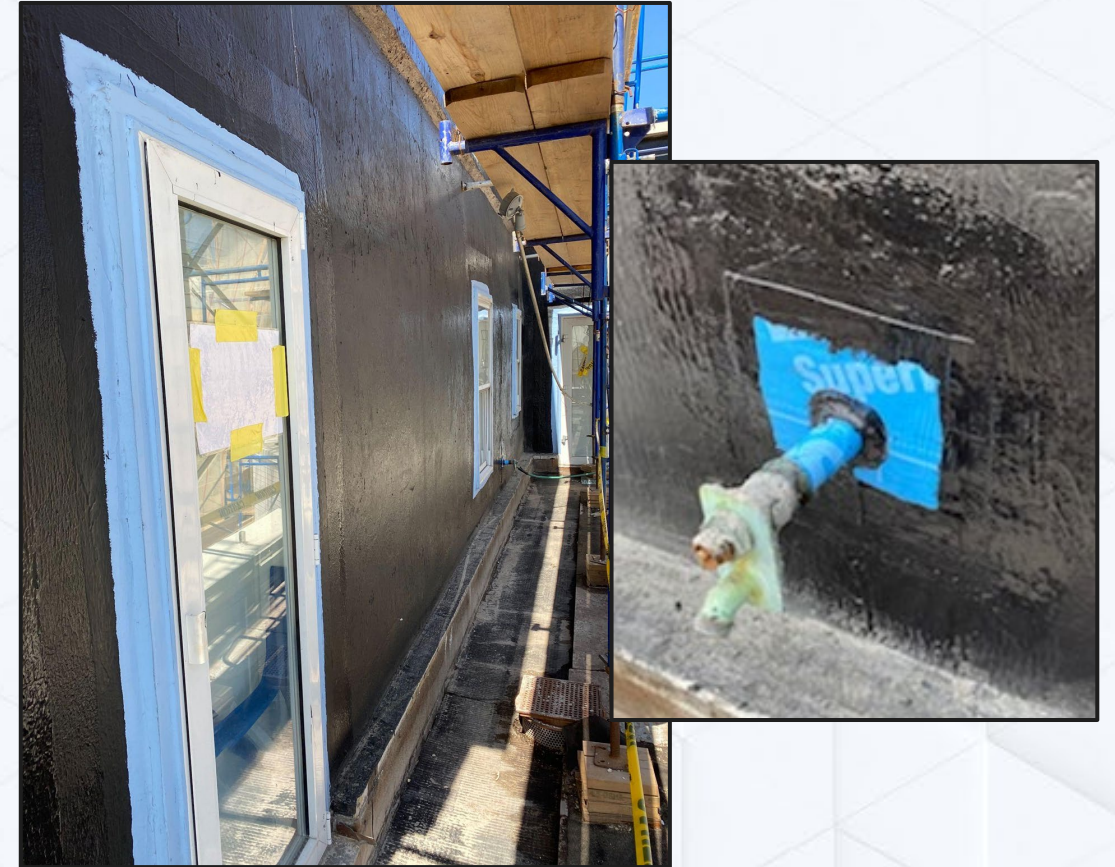
## Patching / Waterproofing

- Consolidation and parging of back up masonry
- Fluid applied air moisture barrier and window flashings
- Leak free for 12+ months prior to cladding install

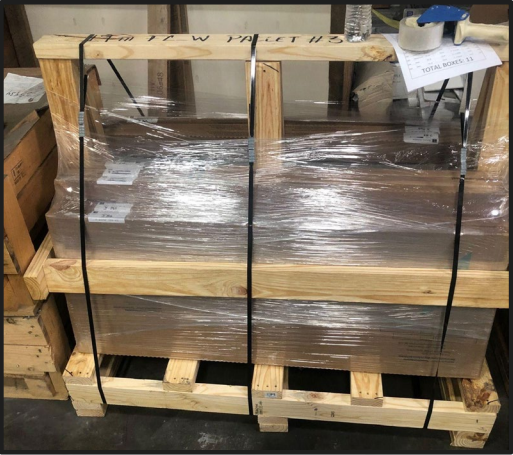
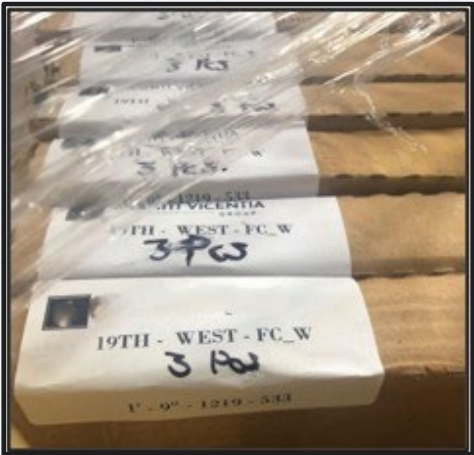
## Cutting / Labeling / Storage

Panel Schedule 19th-Pent - FC_W** (Shop Cut Height plus Miter)					
Floor	Elevation	Cutting Parameter	Quantity	Width	Height
19th	South	FC_W**	3	0' - 9 15/16"	1' - 9"
19th	North	FC_W**	3	1' - 2 1/4"	1' - 9"
19th	North	FC_W**	3	1' - 2 9/16"	1' - 9"
19th	North	FC_W**	3	1' - 10 1/4"	1' - 9"
20th	West	FC_W**	1	1' - 11 9/16"	1' - 6 5/16"
20th	South	FC_W**	1	2' - 1 3/8"	1' - 6 5/16"
20th	West	FC_W**	1	2' - 5 11/16"	1' - 6 5/16"
20th	West	FC_W**	2	2' - 9 7/8"	1' - 6 5/16"
20th	South	FC_W**	1	2' - 10 13/16"	1' - 6 5/16"
20th	West	FC_W**	1	2' - 11 3/16"	1' - 6 5/16"
20th	West	FC_W**	1	3' - 0"	1' - 6 5/16"

- Coordination and management of over 17,000 individual tiles
- Custom sized according to existing windows to remain
- Management of cutting lists/packageing/sorting/labeling

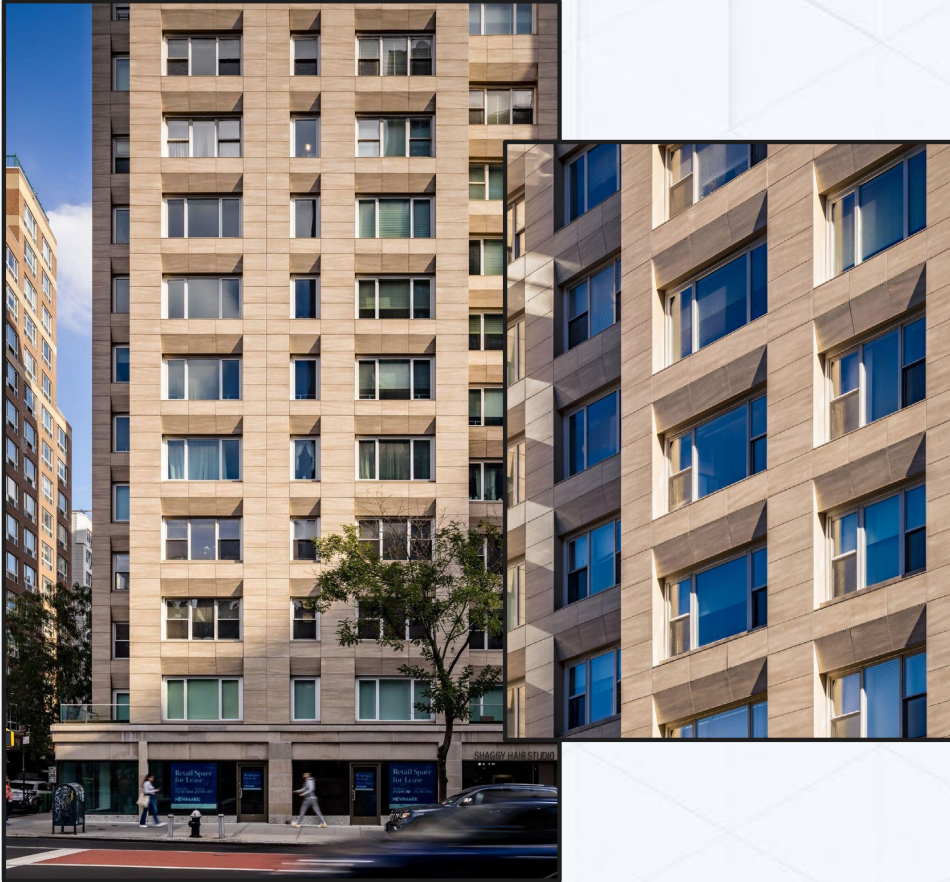
## Porcelain Installation

- Custom painted exposed tile clips
- Oblique tiles at window heads/bay windows
- Custom trim/closure metal around existing window

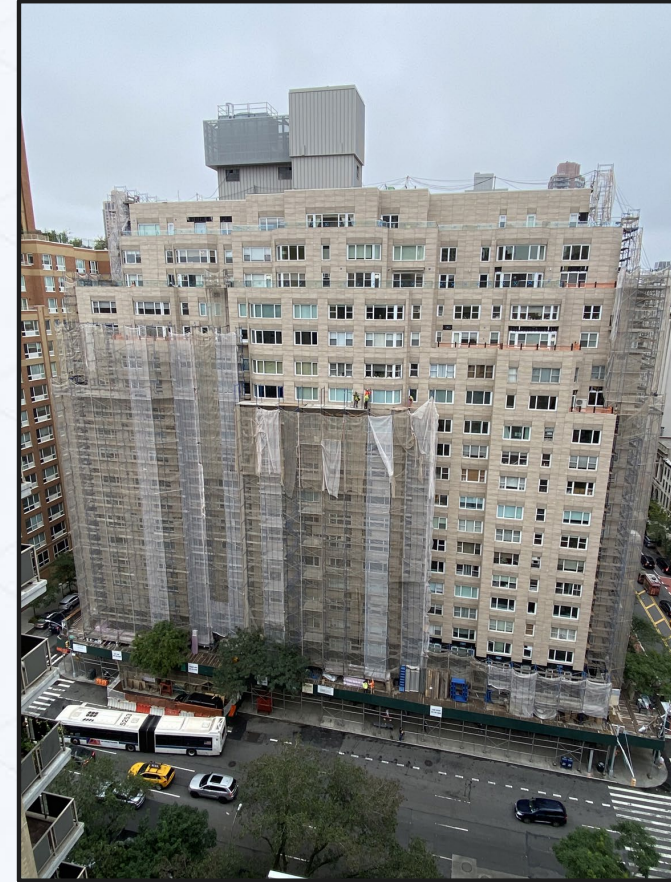
## Phased Scaffold Removal

- Running punch lists and sign-off of discrete zones
- Allows for scaffold removal by zone/elevation

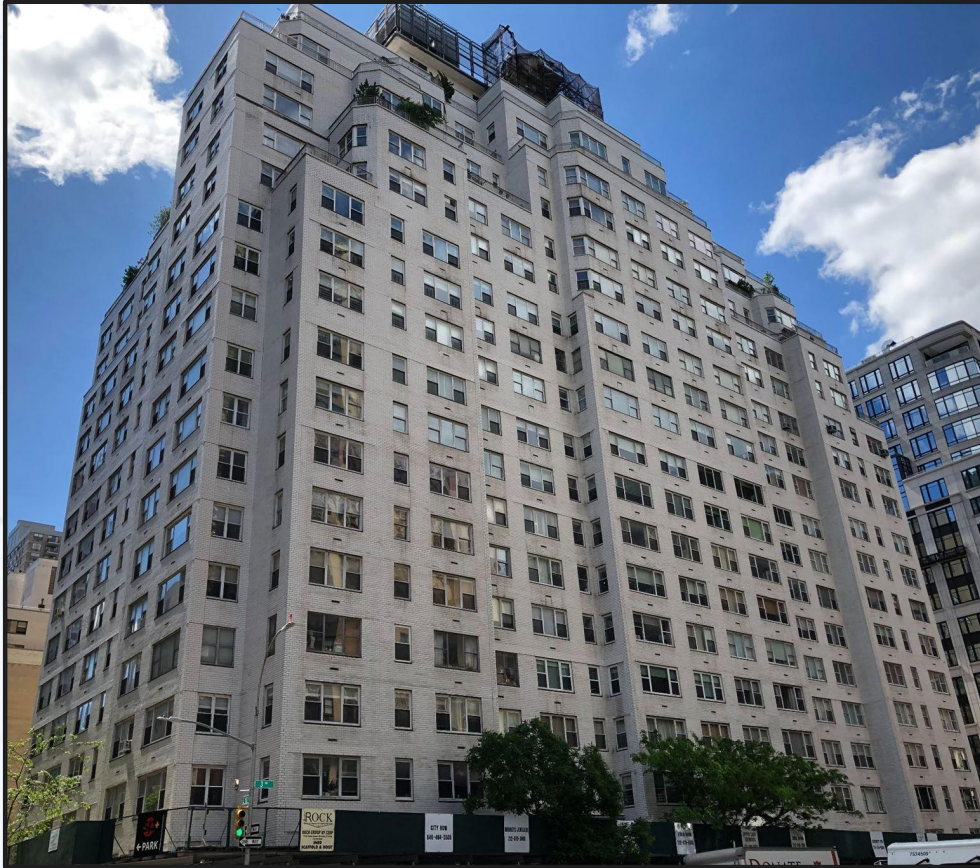
**BEFORE**

- Continuous safety concerns and water/air leaks
- 5 year repeating costs for brick maintenance - scaffolding
- Tenant complaints and poor energy performance
